Manhole Inspection Summary

Manhole # S29UU1021MH

Insp Date: **5/14/07 12:36 PM**

Location Address: **5002 BOXHILL LN**

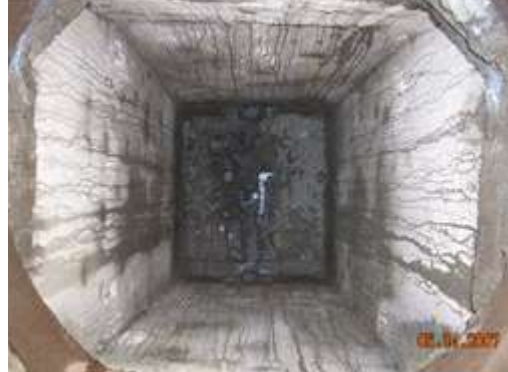
Top View

Channel debris.

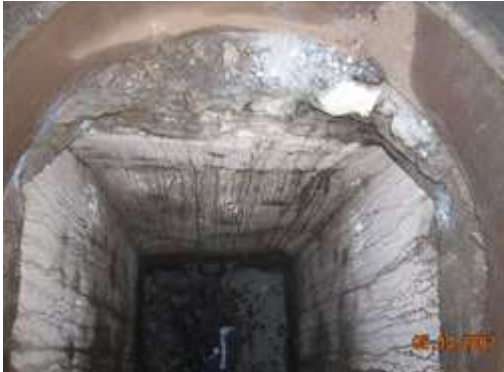
Defect

Frame Offset: **2** (in.) Condition: ☐ Sound ☐ Cracked ☒ **Leaks**

Infiltration: ☐ None ☒ **Joint** ☐ Cracks ☐ Mortar ☐ Roots ☐ Wall

Infiltration: ☐ None ☒ **Joint** ☐ Cracks ☐ Mortar ☐ Roots ☒ **Wall**

Infiltration: ☐ None ☐ Joint ☐ Cracks ☐ Mortar ☐ Roots ☒ **Wall**

Frame leaks. Frame offset. Adjustment deterioration and infiltration. Corbel and Barrel infiltration.

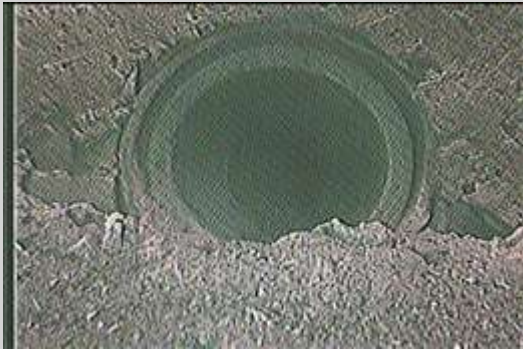
8 in. Circular Gravity Sewer Pipe Out @ 12 O'Clock

Pipe Material: **Clay** ☐ Pipe Lined

Invert Depth: **7.21** (ft.) Flow Characteristics: **None**

Deposits: ☒ None ☐ Mud ☐ Sludge ☐ Debris ☐ Grease

Infiltration: **None**

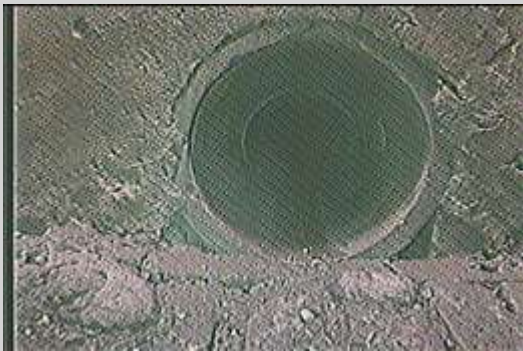
8 in. Circular Gravity Sewer Pipe In @ 6 O'Clock

Pipe Material: **Clay** ☐ Pipe Lined

Invert Depth: **6.95** (ft.) Flow Characteristics: **None**

Deposits: ☒ None ☐ Mud ☐ Sludge ☐ Debris ☐ Grease

Infiltration: **None**
